New York State Department of Transportation

Yellow Flag NB2228W024

BIN: 1065318
Feature Carried: 278I278IX2M23027
Feature Crossed: 6TH AVENUE
Orientation: 8 - NORTHWEST
Region: 11 - NEW YORK CITY
County: KINGS
Political Unit: City of NEW YORK
Approximate Year Built: 1962
Posted Load Matches Inventory : Yes
Bridge Load Posting (Tons) : Not Posted for Load
Primary Owner: New York State Department of Transportation
Primary Maintenance Responsibility: 12 - State - Subcontracted to another Party
Typical or Main Span Type: 3 - Steel, 02 - Stringer/Multi-Beam or Girder
This Bridge is not a Ramp
Number of Spans: 322

Location: Span 236 Girder G1 at Pier 236.

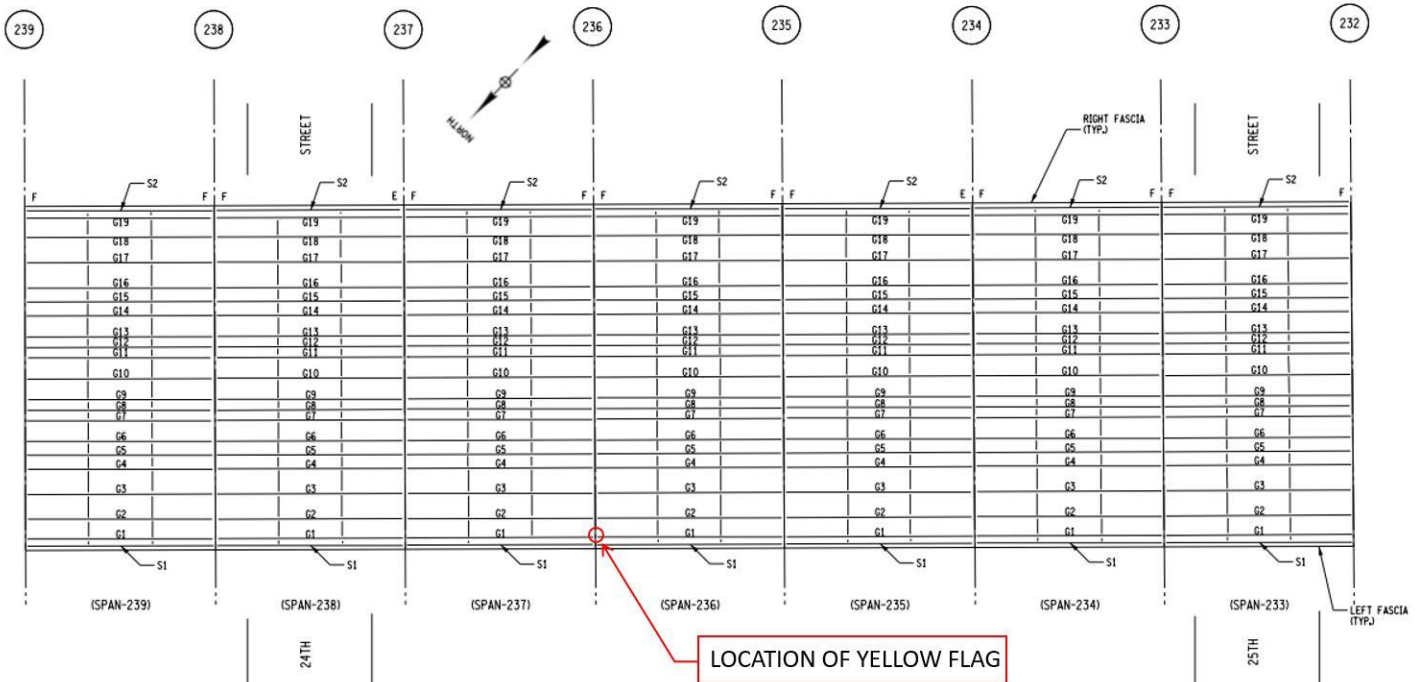
Photo Number: 1

**Attachment Description: BIN 1065318, Framing Plan, Span 236**

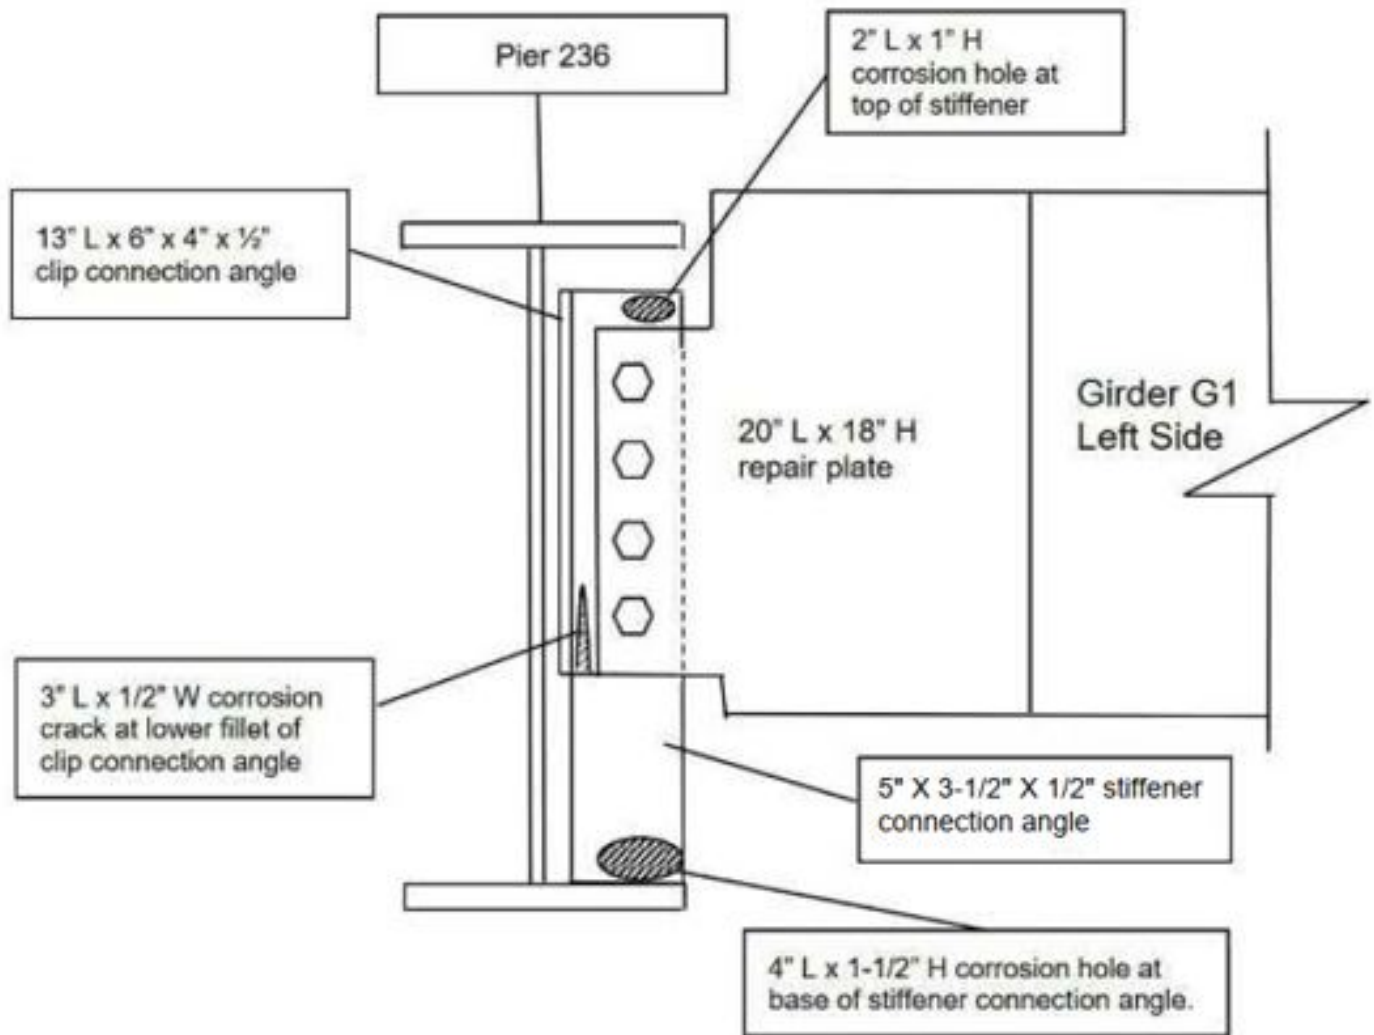
Photo Number: 2

Description: The left clip/connection angle at Girder G1 connection to the pier cap at Pier 236 exhibits a 3" long x 1/2" wide vertical corrosion crack at the lower fillet section. In addition, the right vertical stiffener/connection angle is heavily corroded and has a 4" wide x 1-1/2" high hole at the base and a 2" wide x 1" high corrosion hole at the top of the stiffener.

Span 236, Left side of Girder G1 at Pier 236 – Looking Right

Attachment Description: Sketch of Girder G1 at Pier 236

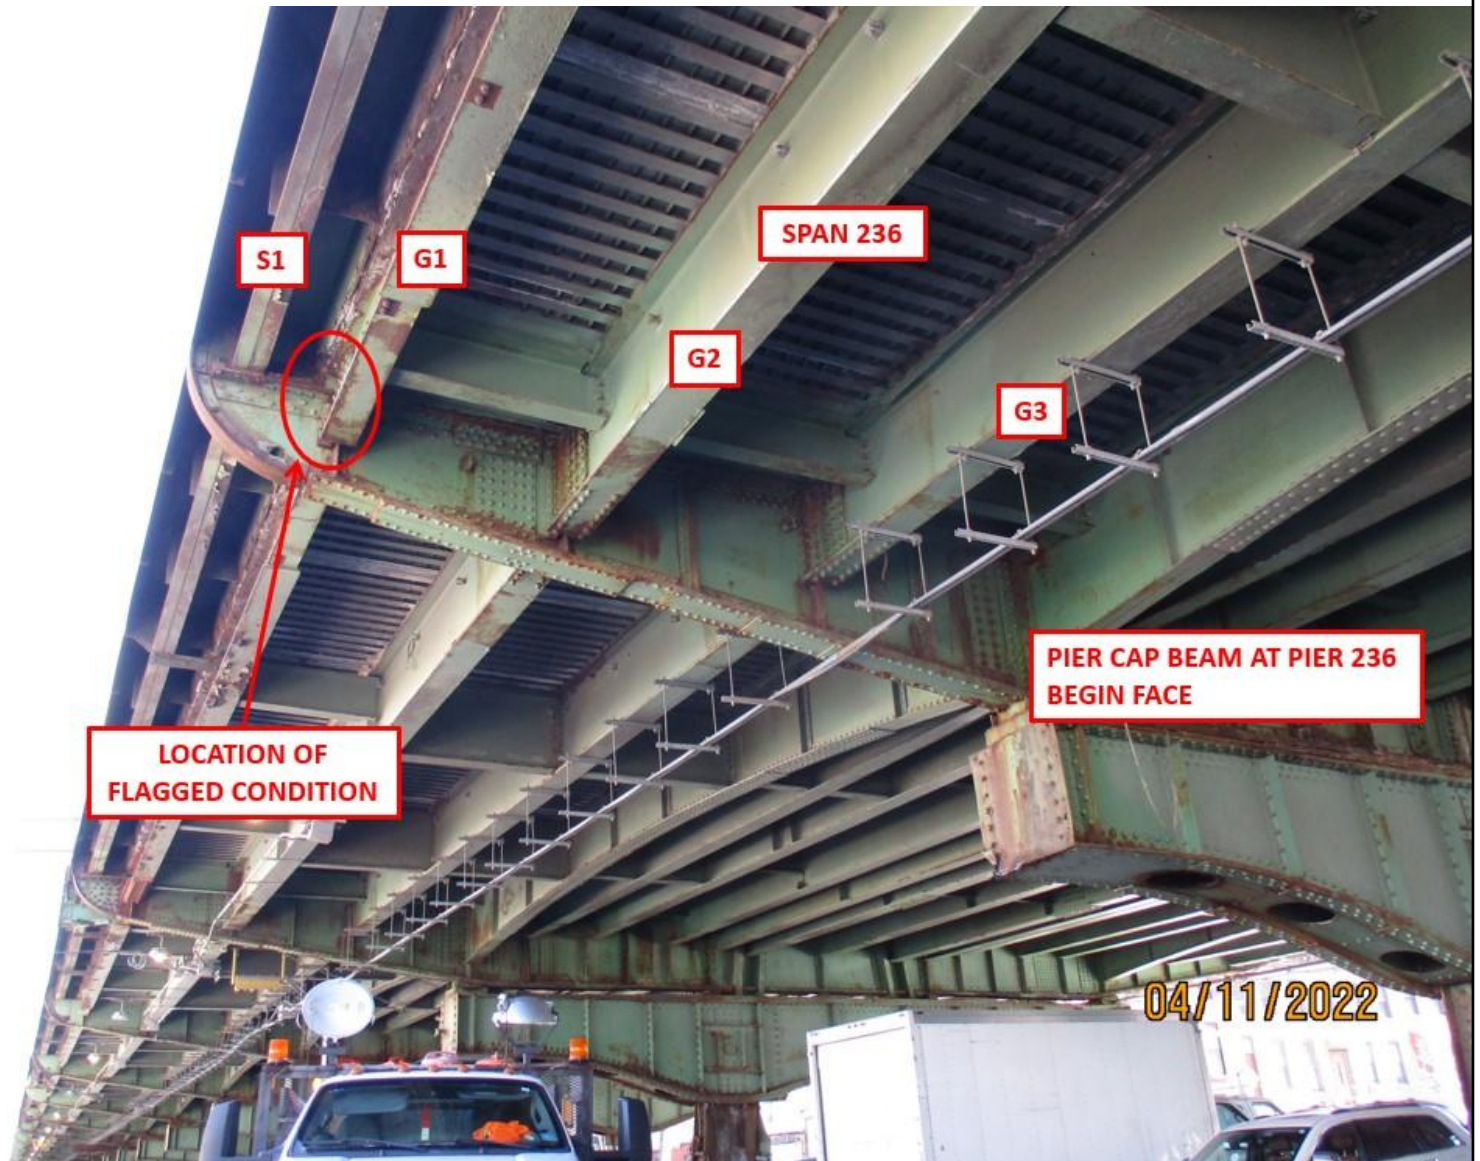
Photo Number: 3

Attachment Description: Span 236, Girder G1 at Pier 236 - General Framing at Flagged Location - Looking End.

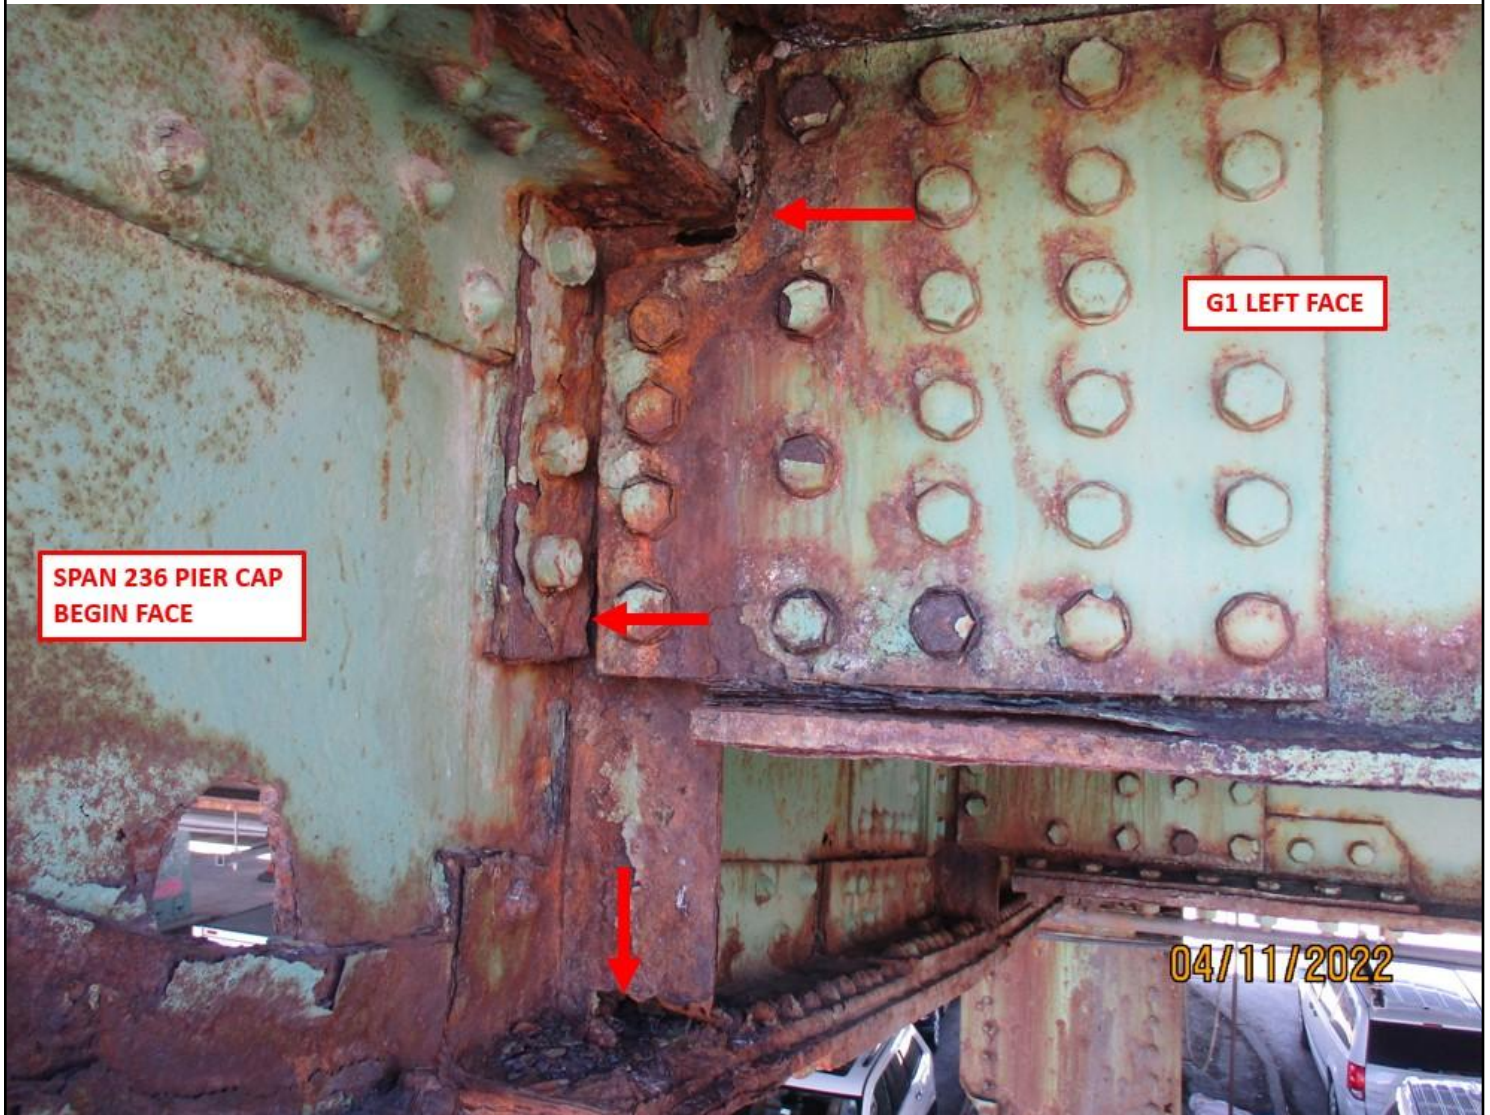
Photo Number: 4

Attachment Description: Span 236, Girder G1 at Pier 236 - General View of Flag Location showing the 3" L x 1/2" W vertical corrosion crack in the left clip/connection angle and the corrosion holes at the upper and lower sections of the right side vertical stiffener/connection angle. Looking Right.

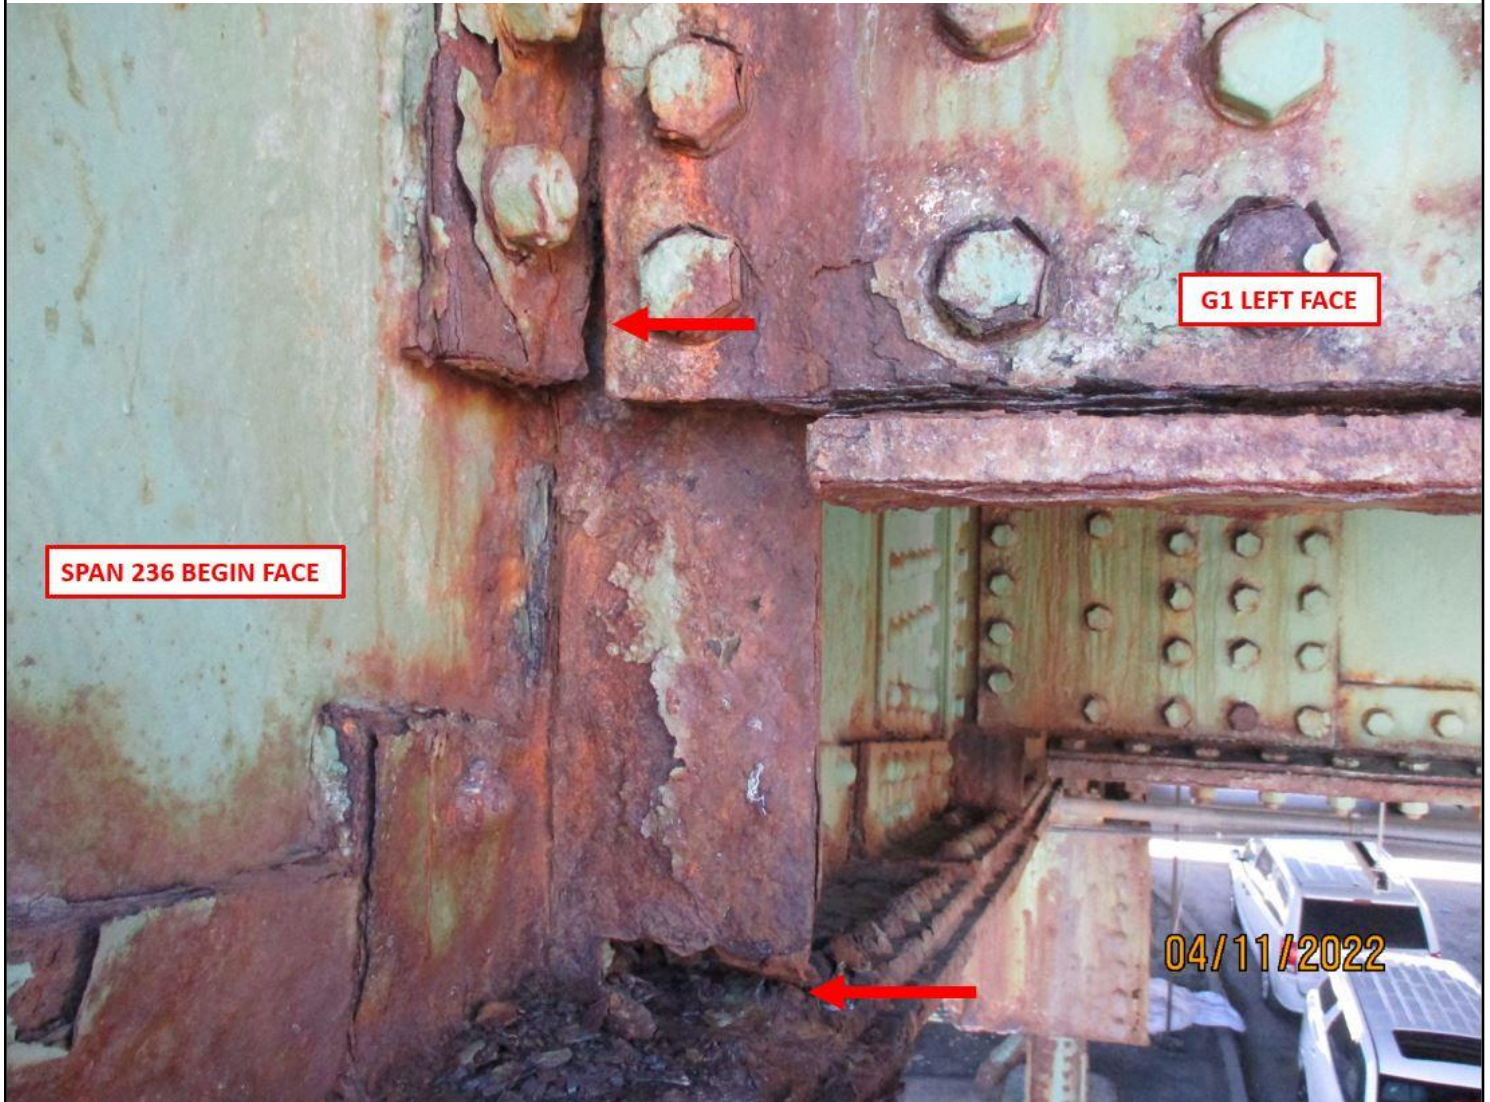
Photo Number: 5

Attachment Description: Span 236, Girder G1 at Pier 236 - Close up view of 3" L x 1/2" W vertical corrosion crack at lower fillet section of left clip connection/angle and 4" L x 1-1/2" W corrosion hole at base of the right side vertical stiffener/connection angle. Looking Right.

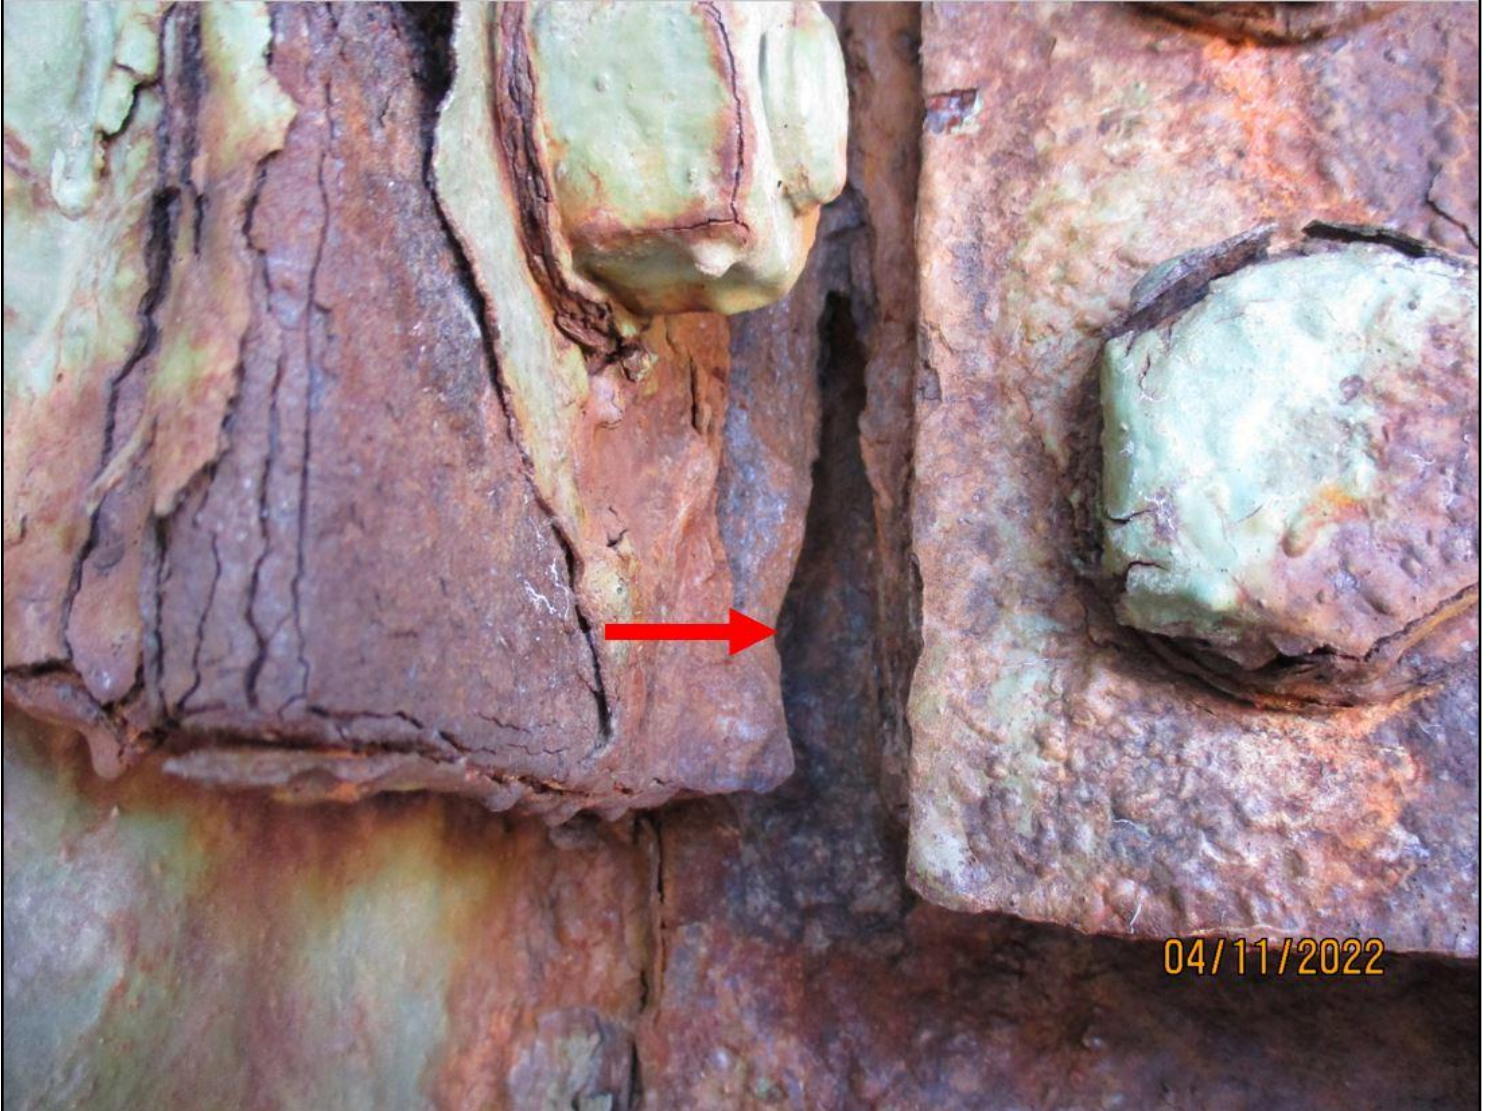
Photo Number: 6

Attachment Description: Span 236, Girder G1 at Pier 236 - Close up view of 3" L x ½" W vertical corrosion crack at lower fillet section of left side clip/connection angle. Looking Right.
